**Flood Control Project Maintenance
Levee Inspections**

Fall 2018 Levee Maintenance Deficiency Summary Report

Sacramento River Basin

**Flood Control Project Maintenance
Levee Inspections****LMA District Cover Sheet****Fall 2018 Levee Inspection Results****Sutter Maintenance Yard Maintenance Area 0013**

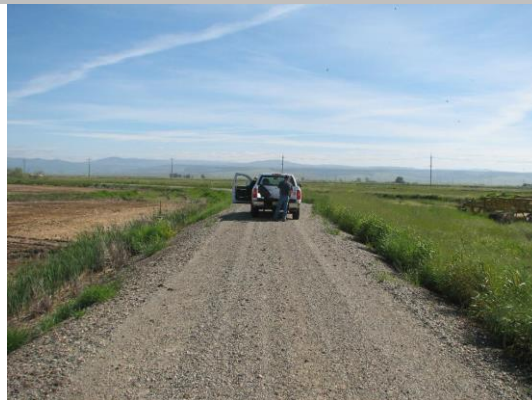
Photo 1 of 3 : UCIP_FA_2018_52125_67119.jpg

FS_ID:52125
DS_ID:16845
EP_NO: N/A
Repair Type: No Action Needed
Crossing Status: Found
UCIP Comments: 6/5/2017 LS Slide gate mostly underwater due to rice field being flooded but crossing appears to be in good condition. Pipe has been selected to be internally cleaned and inspected as part of the DMP project. (DWR Sutter Yard- A Freitag)11/18/2016 Crossing appears to be in good condition. (DWR Sutter Yard- A Freitag)4/27/2016 Crossing appears to be in good condition.7/01/2015 Crossing appears to be in good condition. No noticeable issues to report.5/29/2014 Same as last inspection.12/9/2013 Same as last inspection.7/10/2013 WS slope has been cleared of vegetation and is in good condition.4/19/2012 Limited inspection due to dense vegetation on WS slope. Need photos of clear WS slope.
FIELD_STRUCT_DESC: 24-inch corrugated metal drainage pipe through the levee, 5.6 feet below the crown. Flap gate on the waterside (WS) end. Slide gate on the landside (LS) end. Concrete "U" headwalls on both ends. [Additional Reference(s): DWR Levee Log, 1993. USACE Sacramento O&M Manual 519, June 1962 (HLM 4.69)]

Overview looking east on right levee of Gold Run Creek (referred to Unit 2 of Cherokee Canal).

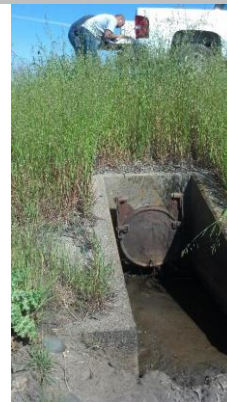
Photo 2 of 3 : UCIP_FA_2018_52125_67122.jpg

Headwall and flap gate located on WS.

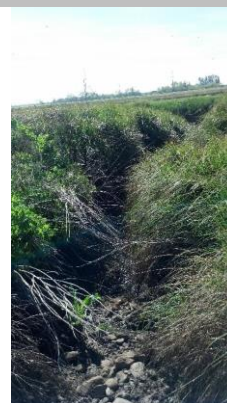
Photo 3 of 3 : UCIP_FA_2018_52125_67123.jpg

Item	DWR UCIP LMA Responsibility			39.532510 °		39.532510 °
				-121.691340 °		-121.691340 °
DWR ID	16845					
Comment Code						
Inspector Comment						
FS_ID:52125 DS_ID:16845 EP_NO: N/A Repair Type: No Action Needed Crossing Status: Found UCIP Comments: 6/5/2017 LS Slide gate mostly underwater due to rice field being flooded but crossing appears to be in good condition. Pipe has been selected to be internally cleaned and inspected as part of the DMP project. (DWR Sutter Yard- AFreitag)11/18/2016 Crossing appears to be in good condition. (DWR Sutter Yard- AFreitag)4/27/2016 Crossing appears to be in good condition.7/01/2015 Crossing appears to be in good condition. No noticeable issues to report.5/29/2014 Same as last inspection.12/9/2013 Same as last inspection.7/10/2013 WS slope has been cleared of vegetation and is in good condition.4/19/2012 Limited inspection due to dense vegetation on WS slope. Need photos of clear WS slope. FIELD_STRUCT_DESC: 24-inch corrugated metal drainage pipe through the levee, 5.6 feet below the crown. Flap gate on the waterside (WS) end. Slide gate on the landside (LS) end. Concrete "U" headwalls on both ends. [Additional Reference(s): DWR Levee Log, 1993. USACE Sacramento O&M Manual 519, June 1962 (HLM 4.69)] FS Date: 6/7/2017 1:41:34 PM

View of channel at crossing.

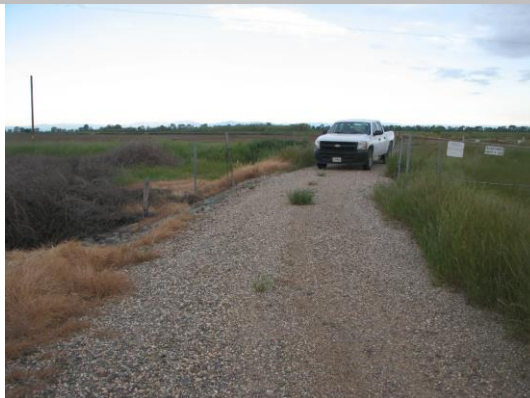
Photo 1 of 3 : UCIP_FA_2018_52126_67131.jpg

FS_ID:52126
DS_ID:16395
EP_NO: N/A
Repair Type: No Action Needed
Crossing Status: Found
UCIP Comments: 6/5/2017 WS mostly submerged but crossing appears to be in good condition.(DWR Sutter Yard- A/Freitag)11/18/2016 Crossing appears to be in good condition. Pipe is a 30" cmp. (DWR Sutter Yard- A/Freitag)4/27/2016 Crossing appears to be in good condition.6/30/2015 Erosion on LS does not appear to be getting any worse with the rip-rap there. WS pipe end and gate appeared in good condition.5/29/2014 Same as last inspection.12/9/2013 Same as last inspection.7/09/2013 Same as last inspection.4/19/2012 Rusted pipe debris located on WS. Remove pipe debris on WS and monitor the LS erosion near headwall. Rip-rap used to protect LS headwall from erosion. Was pipe exposed prior to dumping rock? Erosion on the LS could have exposed pipe. Dense shrub on the LS could restrict flow.
FIELD_STRUCT_DESC: 30-inch corrugated metal drainage pipe through the levee, 8.6 feet below the crown. Flap gate on the waterside (WS) end. Concrete "U" headwalls on both ends. [Additional Reference(s): DWR Levee Log, 1993. USACE Sacramento O&M Manual 519, June 1962 (HLM 5.06)]

Overview looking west on the left levee of Cottonwood

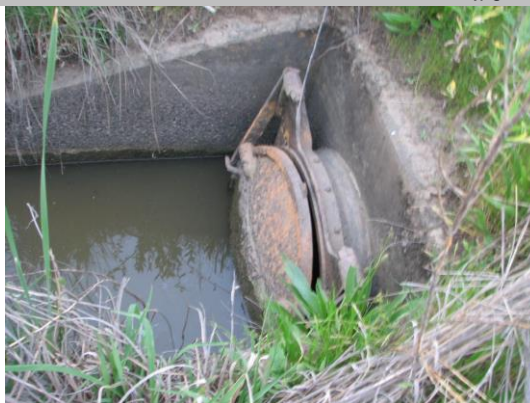
Photo 2 of 3 : UCIP_FA_2018_52126_67129.jpg

Headwall and flap gate located on WS.

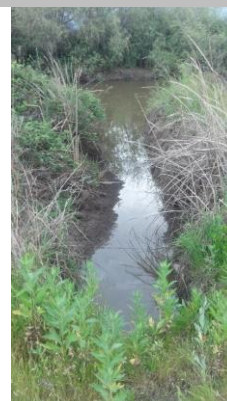
Photo 3 of 3 : UCIP_FA_2018_52126_67126.jpg

Item	DWR UCIP LMA Responsibility			39.526298 °	39.526298 °	
				-121.688320 °	-121.688320 °	
DWR ID	16395					
Comment Code						
Inspector Comment						
FS_ID:52126 DS_ID:16395 EP_NO: N/A Repair Type: No Action Needed Crossing Status: Found UCIP Comments: 6/5/2017 WS mostly submerged but crossing appears to be in good condition.(DWR Sutter Yard-AFreitag)11/18/2016 Crossing appears to be in good condition. Pipe is a 30" cmp. (DWR Sutter Yard- AFreitag)4/27/2016 Crossing appears to be in good condition.6/30/2015 Erosion on LS does not appear to be getting any worse with the rip-rap there. WS pipe end and gate appeared in good condition.5/29/2014 Same as last inspection.12/9/2013 Same as last inspection.7/09/2013 Same as last inspection.4/19/2012 Rusted pipe debris located on WS. Remove pipe debris on WS and monitor the LS erosion near headwall. Rip-rap used to protect LS headwall from erosion. Was pipe exposed prior to dumping rock? Erosion on the LS could have exposed pipe. Dense shrub on the LS could restrict flow. FIELD_STRUCT_DESC: 30-inch corrugated metal drainage pipe through the levee, 8.6 feet below the crown. Flap gate on the waterside (WS) end. Concrete "U" headwalls on both ends. [Additional Reference(s): DWR Levee Log, 1993. USACE Sacramento O&M Manual 519, June 1962 (HLM 5.06)] FS Date: 6/7/2017 1:54:08 PM

View of channel at crossing.

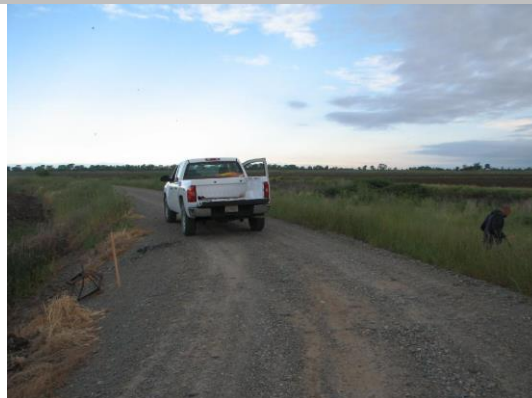
Photo 1 of 3 : UCIP_FA_2018_52129_67138.jpg

FS_ID:52129
DS_ID:16408
EP_NO: N/A
Repair Type: No Action Needed
Crossing Status: Found
UCIP Comments: 6/5/2017 Crossing appears to be in good condition. Pipe has been selected to be internally cleaned and inspected as part of the DMP project. (DWR Sutter Yard- A Freitag)11/18/2016 Crossing appears to be in good condition. (DWR Sutter Yard- A Freitag)4/27/2016 Crossing appears to be in good condition.6/30/2015 Crossing appears to be in good condition. No apparent issues to report.5/29/2014 Same as last inspection.12/9/2013 Same as last inspection.7/09/2013 WS and LS slopes have been cleared of vegetation and are in good condition. Slide gate on LS has been replaced.4/24/2012 Slide gate is damaged, needs to be replaced. Limited inspection on WS slope and toe due to dense vegetation. Need photos of clear WS slope and toe. This crossing was listed in the USACE Periodic Inspection report as Corp's inspection ID# USACE_CESPK_M13H_2011_p_0026 for broken gate on LS.

Overview of levee crown at crossing looking west.

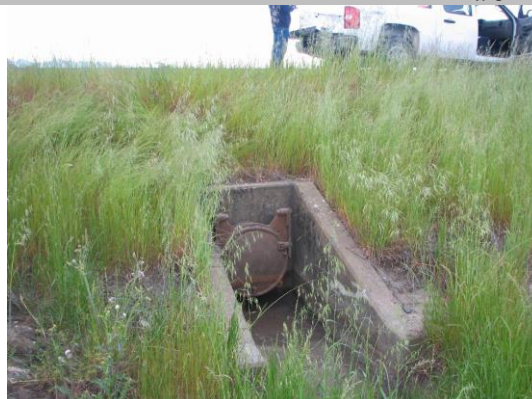
Photo 2 of 3 : UCIP_FA_2018_52129_67140.jpg

Headwall and flap gate located on WS.

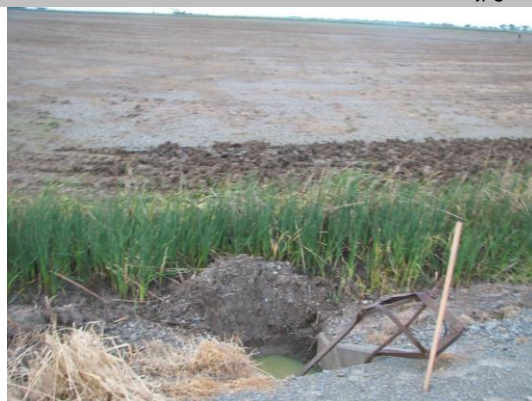
Photo 3 of 3 : UCIP_FA_2018_52129_67141.jpg

FS_ID:52129
DS_ID:16408
EP_NO: N/A
Repair Type: No Action Needed
Crossing Status: Found
UCIP Comments: 6/5/2017 Crossing appears to be in good condition. Pipe has been selected to be internally cleaned and inspected as part of the DMP project. (DWR Sutter Yard- A Freitag) 11/18/2016 Crossing appears to be in good condition. (DWR Sutter Yard- A Freitag) 4/27/2016 Crossing appears to be in good condition. 6/30/2015 Crossing appears to be in good condition. No apparent issues to report. 5/29/2014 Same as last inspection. 12/9/2013 Same as last inspection. 7/09/2013 WS and LS slopes have been cleared of vegetation and are in good condition. Slide gate on LS has been replaced. 4/24/2012 Slide gate is damaged, needs to be replaced. Limited inspection on WS slope and toe due to dense vegetation. Need photos of clear WS slope and toe. This crossing was listed in the USACE Periodic Inspection report as Corp's inspection ID# USACE_CESPK_M13H_2011_p_0026 for broken gate on LS.

Overview of LS floor is higher in elevation than pipe invert causing build up sediment.

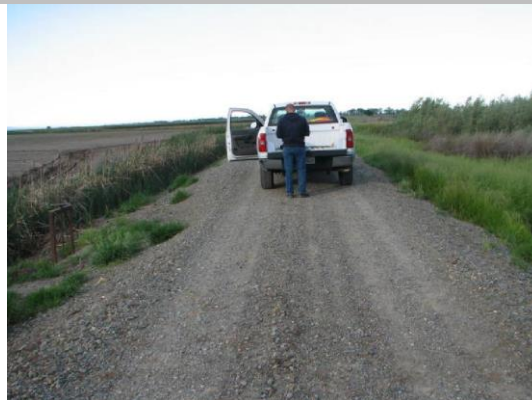
Photo 1 of 3 : UCIP_FA_2018_52130_67146.jpg

Comment Code						
Inspector Comment						
FS_ID:52130 DS_ID:16409 EP_NO: N/A Repair Type: Non-Urgent Crossing Status: Found UCIP Comments: 6/5/2017 WS fully submerged and LS slide gate mostly buried by sediment. Pipe has been selected to be internally cleaned and inspected as part of the DMP project. (DWR Sutter Yard-AFreitag)11/18/2016 There is a flapgate on the WS and a slide gate on the LS. The LS slide gate appears to be partially buried and blocked by vegetation. (DWR Sutter Yard-AFreitag)4/27/2016 LS slide gate is blocked by vegetation. Pipe appears to not be used.6/30/2015 WS flap gate was still overgrown with vegetation. Needs to be cleared away.5/29/2014 Same as last inspection.12/9/2013 Same as last inspection.7/09/2013 Same as last inspection.4/24/2012 Limited inspection on WS slope due to dense vegetation. Need photo of clear WS slope during next inspection. This crossing was listed in the USACE Periodic Inspection report as Corp's inspect ID# USACE_CESPK_M13H_2011_p_0035 non-functional crossing due to overgrown vegetation on WS flap gate. FIELD_STRUCT_DESC: 30-inch corrugated metal drainage pipe through the levee, 5.8 feet below the crown. Flap gate on the waterside (WS). Slide gate on the landside (LS). Concrete "U" headwalls located on both ends. [Additional Reference(s): DWR Levee Log, 1993. USACE Sacramento O&M Manual 519, June 1962 (HLM 5.34)] FS Date: 6/7/2017 2:02:27 PM

Overview of crossing looking downstream.

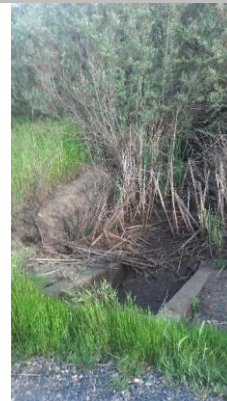
Photo 2 of 3 : UCIP_FA_2018_52130_67149.jpg

View of WS headwall with dense vegetation in channel.

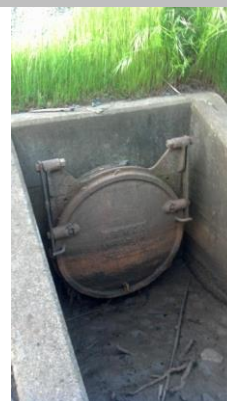
Photo 3 of 3 : UCIP_FA_2018_52130_67148.jpg

Comment Code						
Inspector Comment						
FS_ID:52130 DS_ID:16409 EP_NO: N/A Repair Type: Non-Urgent Crossing Status: Found UCIP Comments: 6/5/2017 WS fully submerged and LS slide gate mostly buried by sediment. Pipe has been selected to be internally cleaned and inspected as part of the DMP project. (DWR Sutter Yard-AFreitag)11/18/2016 There is a flapgate on the WS and a slide gate on the LS. The LS slide gate appears to be partially buried and blocked by vegetation. (DWR Sutter Yard- AFreitag)4/27/2016 LS slide gate is blocked by vegetation. Pipe appears to not be used.6/30/2015 WS flap gate was still overgrown with vegetation. Needs to be cleared away.5/29/2014 Same as last inspection.12/9/2013 Same as last inspection.7/09/2013 Same as last inspection.4/24/2012 Limited inspection on WS slope due to dense vegetation. Need photo of clear WS slope during next inspection. This crossing was listed in the USACE Periodic Inspection report as Corp's inspect ID# USACE_CESPK_M13H_2011_p_0035 non-functional crossing due to overgrown vegetation on WS flap gate. FIELD_STRUCT_DESC: 30-inch corrugated metal drainage pipe through the levee, 5.8 feet below the crown. Flap gate on the waterside (WS). Slide gate on the landside (LS). Concrete "U" headwalls located on both ends. [Additional Reference(s): DWR Levee Log, 1993. USACE Sacramento O&M Manual 519, June 1962 (HLM 5.34)] FS Date: 6/7/2017 2:02:27 PM

Headwall and flap gate located on WS.

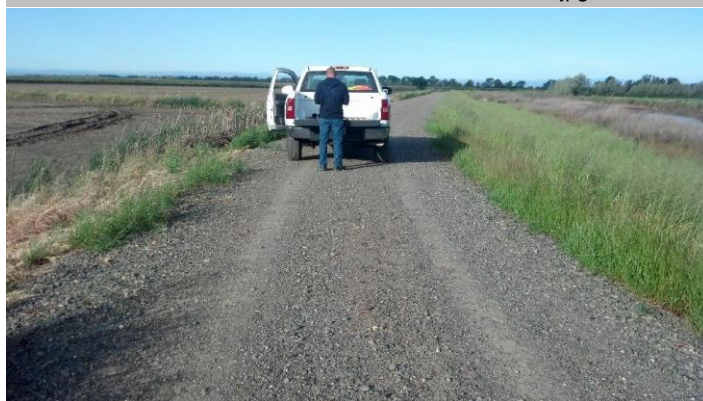
Photo 1 of 3 : UCIP_FA_2018_52131_67152.jpg

FS_ID:52131
DS_ID:16410
EP_NO: N/A
Repair Type: Non-Urgent
Crossing Status: Found
UCIP Comments: 6/5/2017 Abandoned- needs to be done properly.
(DWR Sutter Yard- AFreitag)11/18/2016 Abandoned pipe. It is still present on both sides of the levee and capped on the WS. (DWR Sutter Yard- AFreitag)4/27/2016 Pipe appears abandoned. Should be removed.6/30/2015 Pipe still present with the cap on the waterside.5/29/2014 Same as last inspection.12/9/2013 Same as last inspection.7/09/2013 Same as last inspection.4/24/2012 Limited inspection on WS and LS slope due to dense vegetation. Need photos of clear slopes during next inspection. Metal plate bolted on pipe for closure on WS, open on LS.
FIELD_STRUCT_DESC: *ABANDONED* 6-inch steel pipe through the levee, 1.6 feet below the crown. Plate bolted on the waterside (WS) end. Open on the landside (LS) end. [Additional Reference(s): DWR Levee Log, 1993. USACE Sacramento O&M Manual 519, June 1962 (HLM 5.41)]

Overview of site

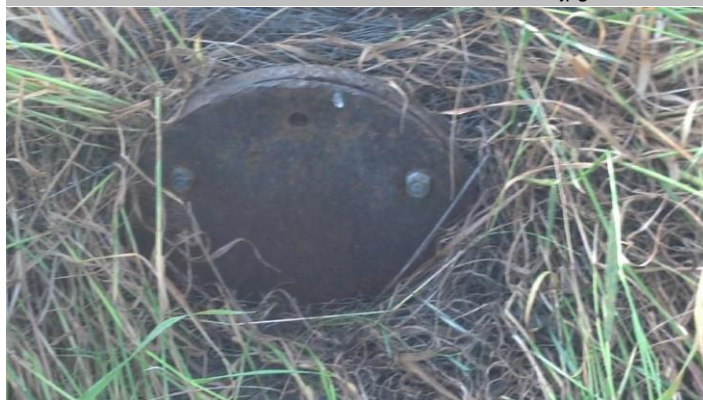
Photo 2 of 3 : UCIP_FA_2018_52131_67150.jpg

Capped irrigation pipe located on water side of levee

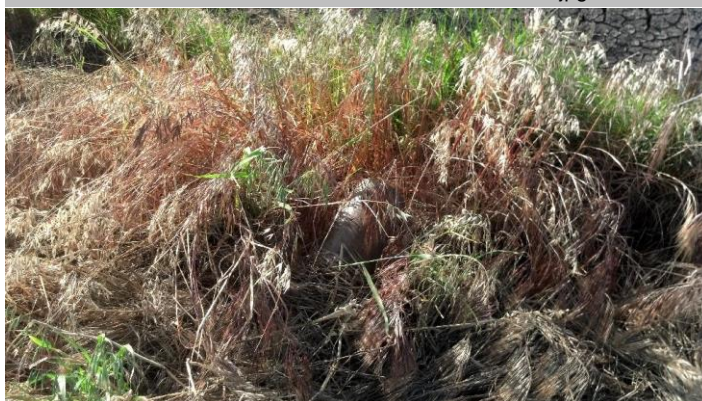
Photo 3 of 3 : UCIP_FA_2018_52131_67153.jpg

Comment Code						
Inspector Comment						
FS_ID:52131 DS_ID:16410 EP_NO: N/A Repair Type: Non-Urgent Crossing Status: Found UCIP Comments: 6/5/2017 Abandoned- needs to be done properly. (DWR Sutter Yard- AFreitag)11/18/2016 Abandoned pipe. It is still present on both sides of the levee and capped on the WS. (DWR Sutter Yard- AFreitag)4/27/2016 Pipe appears abandoned. Should be removed.6/30/2015 Pipe still present with the cap on the waterside.5/29/2014 Same as last inspection.12/9/2013 Same as last inspection.7/09/2013 Same as last inspection.4/24/2012 Limited inspection on WS and LS slope due to dense vegetation. Need photos of clear slopes during next inspection. Metal plate bolted on pipe for closure on WS, open on LS. FIELD_STRUCT_DESC: *ABANDONED* 6-inch steel pipe through the levee, 1.6 feet below the crown. Plate bolted on the waterside (WS) end. Open on the landside (LS) end. [Additional Reference(s): DWR Levee Log, 1993. USACE Sacramento O&M Manual 519, June 1962 (HLM 5.41)] FS Date: 6/7/2017 2:04:03 PM

View of LS toe.

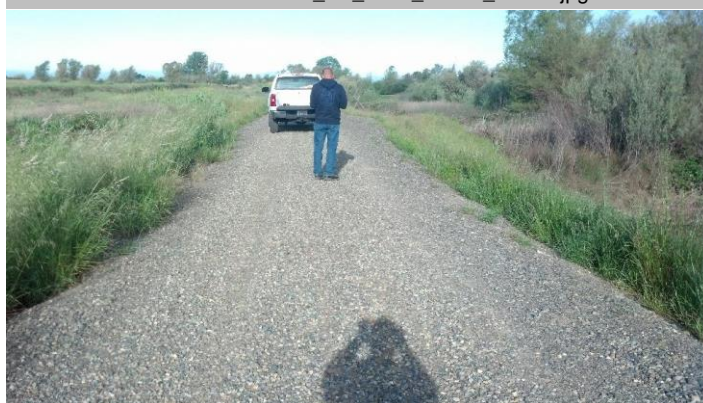
Photo 1 of 3 : UCIP_FA_2018_52132_67155.jpg

Comment Code					
Inspector Comment					
FS_ID:52132 DS_ID:16411 EP_NO: N/A Repair Type: Non-Urgent Crossing Status: Found UCIP Comments: 6/5/2017 Both ends were underwater but it appears that the LS slide gate is still missing. (DWR Sutter Yard- AFreitag)11/18/2016 LS slide gate still missing. Both pipe ends were submerged during inspection. (DWR Sutter Yard- AFreitag)9/27/2016 Crossing has been downgraded from Urgent to Non-Urgent--flap gate on WS is present only LS gate missing. (DWR UCIP - omagana)4/27/2016 Both sides of pipe were underwater. Appears that LS gate is still missing. (DWR Sutter Yard - afreitag)6/30/2015 Slide gate still missing on the LS. WS appears to be in good condition. (DWR Sutter Yard - afreitag)5/29/2014 Same as last inspection. (DWR Sutter Yard - afreitag)12/9/2013 Same as last inspection. (DWR Sutter Yard - afreitag)7/09/2013 Same as last inspection. (DWR Sutter Yard - afreitag)4/24/2012 Slide gate missing on LS. Limited inspection on WS and LS slopes due to dense vegetation. Need photos of cleared WS & LS slopes. This crossing was listed in the USACE Periodic Inspection report as Corp's inspect ID# USACE_CESPK_M13H_2011_p_0017 for missing slide gate. (DWR Sutter Yard - omagana) FIELD_STRUCT_DESC: 36-inch corrugated metal drainage pipe through the levee, 9.2 feet below the crown. Flap gate on the waterside (WS) end. Slide gate on the landside (LS) end. Concrete "U" headwalls located on both WS and LS toes. [Additional Reference(s): DWR Levee Log, 1993. USACE Sacramento O&M Manual 519, June 1962 (HLM 5.85)] FS Date: 6/7/2017 2:06:17 PM

Overview looking south

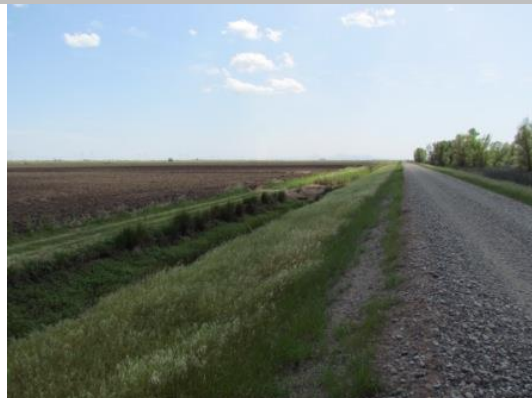
Photo 1 of 1 : FA_2018_MA0013_301_12_20180905_00004.jpg

LM Start	6.18	Rating **	M	Issue No.	12
LM End	7.54	Issue Type +	En	Location *	LS
Category	Earthen Levee			GPS Latitude/Longitude	
				Start	End
Item	Encroachments			39.520843 °	39.502958 °
				-121.706345 °	-121.716953 °
DWR ID	DWR_MA0013_02_s_2012_12				
Comment Code					
DT : Ditch					
Inspector Comment

View of the agricultural ditch along the toe.

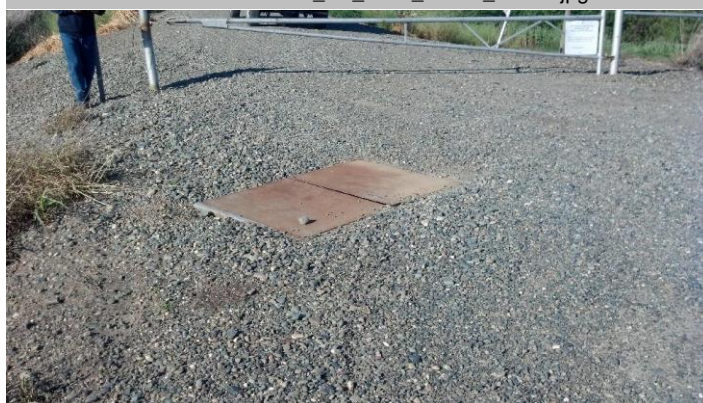
Photo 1 of 2 : UCIP_FA_2018_52140_67191.jpg

FS_ID:52140
DS_ID:16413
EP_NO: 14704
Repair Type: Non-Urgent
Crossing Status: Indicator Found
UCIP Comments: 6/5/2017 Crossing appears to be in good condition.
(DWR Sutter Yard- A Freitag)11/18/2016 Crossing appears to be in good condition.
(DWR Sutter Yard- A Freitag)4/27/2016 Crossing appears to be in good condition.
6/30/2015 Crossing is in good condition. Unusre on the permit issues below.
11/4/2014 (DWR-Olivia Magana) Need to contact owner to determine whether both communication are still active and same alignment? permit 14704 (LM 8.38) and 10589 (see LM 8.39) Priority changed in Part IX from No Action Needed to Non-Urgent.
5/29/2014 Same as last inspection.
12/4/2013 Same as last inspection.
7/09/2013 Same as last inspection.
4/24/2012 Unable to verify whether this crossing includes both communication cable lines under permit 14704 (LM 8.38) and 10589 (see LM 8.39).
FIELD_STRUCT_DESC: Steel fiber optic cable through the levee, approximately 3.5 feet below the crown. The cable section across the channel is attached to the Cherokee Canal Dridge. (Permit No. 14704, 1987 - Sprint) [Additional Reference(s): DWR Levee Log, 1993]

Buried cable box located on the LS edge.

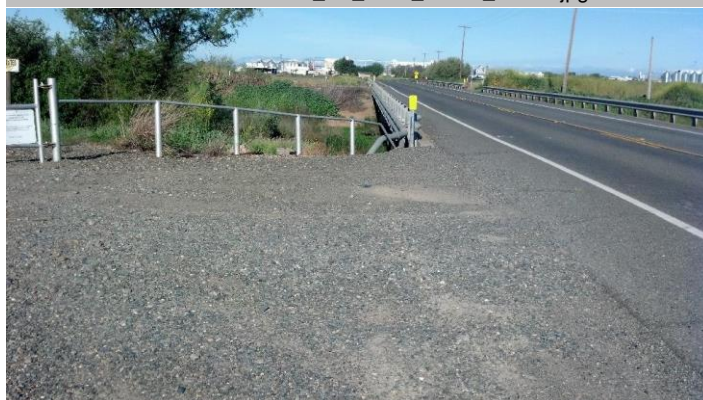
Photo 2 of 2 : UCIP_FA_2018_52140_67192.jpg

WS view cable line attached to highway bridge.

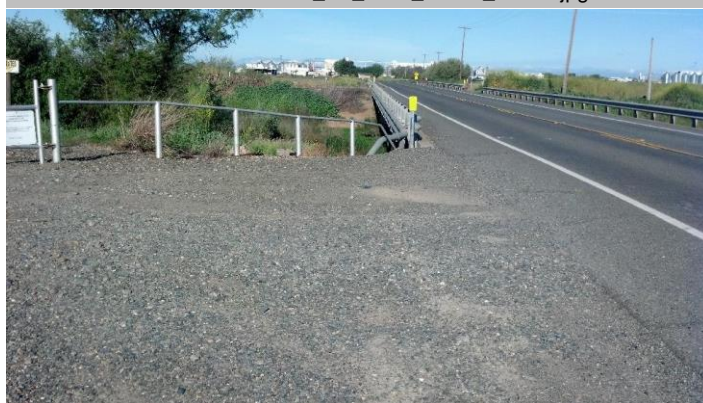
Photo 2 of 2 : UCIP_FA_2018_52141_67210.jpg

FS_ID:52141
DS_ID:16404
EP_NO: 10589A
Repair Type: Non-Urgent
Crossing Status: Indicator Found
UCIP Comments: 6/5/2017 Crossing appears to be in good condition. (DWR Sutter Yard- AFreitag)11/18/2016 Crossing appears to be in good condition. (DWR Sutter Yard- AFreitag)4/27/2016 Crossing appears to be in good condition.6/30/2015 Crossing appears in good condition. Unsure on the permit issues listed below.11/4/2014 (DWR- Olivia Magana) Need to contact owner to determine whether both communication are still active and same alignment? permit 14704 (LM 8.38) and 10589 (see LM 8.39) Priority changed in Part IX from No Action Needed to Non-Urgent.5/29/2014 Same as last inspection.12/4/2013 Same as last inspection.7/09/2013 Same as last inspection.4/24/2012 Unable to verify whether this crossing includes both communication cable lines under permit 14704 (LM 8.38) and 10589 (see LM 8.39).
FIELD_STRUCT_DESC: 4-inch steel communication pipe, contains three telephone cables, through the levee, approximately 4 feet below the crown. The cable through the channel is buried approximately 5 feet deep. (Permit No. 10589, 1987 - Pacific Telephone and Telegraph Company [PT&T]) [Additional Reference(s): DWR Levee Log, 1993]

Waterside view of utility line alignment through levee then attached to bridge.

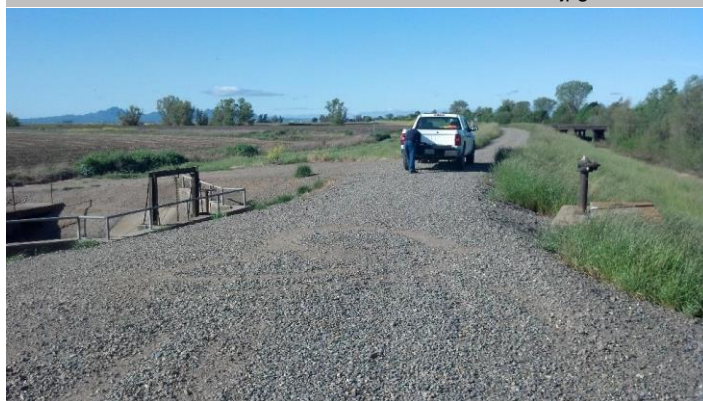
Photo 1 of 3 : UCIP_FA_2018_52145_67280.jpg

FS_ID:52145
DS_ID:16838
EP_NO: N/A
Repair Type: No Action Needed
Crossing Status: Found
UCIP Comments: 6/5/2017 Crossing appears to be in good condition. (DWR Sutter Yard- A Freitag) 11/18/2016 Crossing appears to be in good condition. (DWR Sutter Yard- A Freitag) 4/27/2016 Crossing appears to be in good condition. 6/30/2015 Path to access the WS flap gate was getting overgrown with vegetation but other than that everything with the crossing looked in good condition. 5/28/2014 Same as last inspection. 12/4/2013 Same as last inspection. 4/24/2012 This crossing was listed in the USACE Periodic Inspection report as Corp's inspect ID# USACE_CESPK_M13F_2011_p_0080 for limited visibility of LS slide gate and WS flap gate. 7/9/2013 Same as last inspection.
FIELD_STRUCT_DESC: 36-inch corrugated metal drainage pipe through the levee, 11.2 feet below the crown. Crossing drains into Cherokee Canal and is part of the Richvale Irrigation District siphon structure. Slide gate is located on the landside (LS). Flap gate is located on the waterside (WS). Crossing angles to the southwest to a flap gate and headwall located about 60 feet from WS toe. [Additional Reference(s): USACE Sacramento O&M Manual 519, June 1962 (HLM 9.66)]

Overview of levee crown at crossing looking D/S.

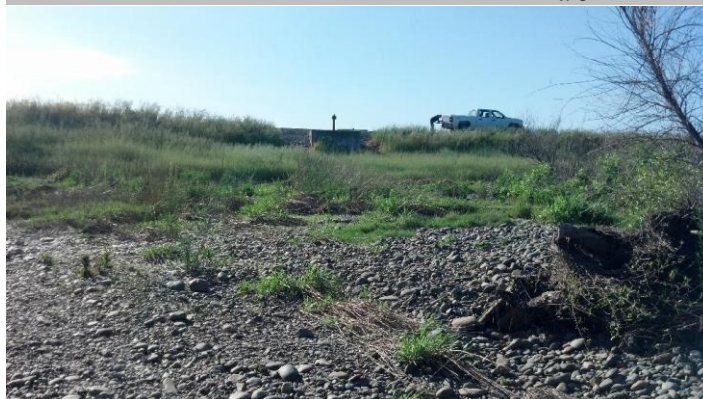
Photo 2 of 3 : UCIP_FA_2018_52145_67285.jpg

View of crossing looking from channel towards WS levee.

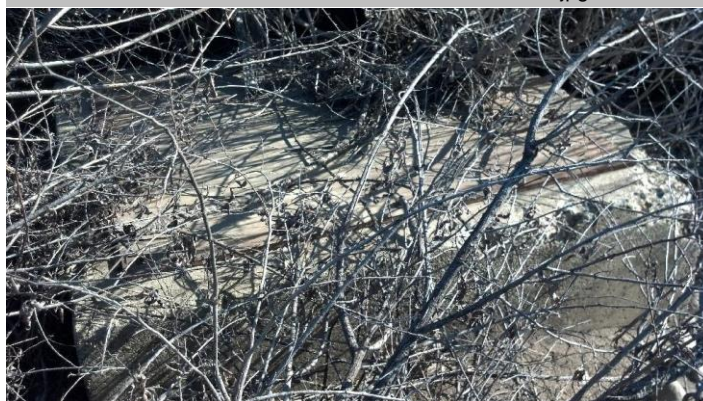
Photo 3 of 3 : UCIP_FA_2018_52145_67283.jpg

WS view-access well located 60 feet from WS toe.

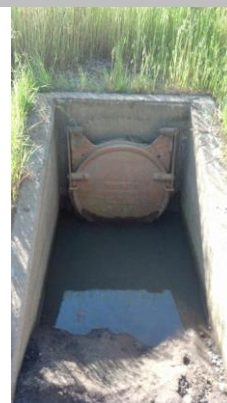
Photo 1 of 3 : UCIP_FA_2018_52146_67289.jpg

Comment Code						
Inspector Comment						
FS_ID:52146 DS_ID:16839 EP_NO: N/A Repair Type: No Action Needed Crossing Status: Found UCIP Comments: 6/5/2017 Crossing appears to be in good condition. (DWR Sutter Yard- AFreitag)11/18/2016 Crossing appears to be in good condition. (DWR Sutter Yard- AFreitag)4/27/2016 Crossing appears to be in good condition.6/30/2015 WS flapgate is silted over and unable to open. Needs to be dug out.5/28/2014 Same as last inspection.12/4/2013 Slopes were cleared of vegetation and are in good condition.7/09/2013 Same as last inspection.4/24/2012 Limited inspection on WS and LS slopes due to dense vegetation. Need photos of WS and LS slopes during next inspeciton with cleared slopes. FIELD_STRUCT_DESC: 30-inch corrugated metal drainage pipe through the levee, 11.5 feet below the crown. Flap gate on the waterside (WS). [Additional Reference(s): USACE Sacramento O&M Manual 519, June 1962 (HLM 9.68)] FS Date: 6/8/2017 8:20:37 AM

WS view of crossing. Dense vegetation along WS slope limited visual inspection. (WS Photo 1 of 2)

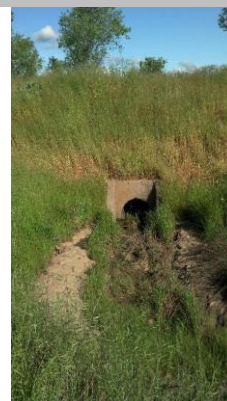
Photo 3 of 3 : UCIP_FA_2018_52146_67286.jpg

Item	DWR UCIP LMA Responsibility			39.477335 °	39.477335 °	
				-121.735340 °	-121.735340 °	
DWR ID	16839					
Comment Code						
Inspector Comment						
FS_ID:52146						
DS_ID:16839						
EP_NO: N/A						
Repair Type: No Action Needed						
Crossing Status: Found						
UCIP Comments: 6/5/2017 Crossing appears to be in good condition.						
(DWR Sutter Yard- AFreitag)11/18/2016 Crossing appears to be in						
good condition. (DWR Sutter Yard- AFreitag)4/27/2016 Crossing						
appears to be in good condition.6/30/2015 WS flapgate is silted over						
and unable to open. Needs to be dug out.5/28/2014 Same as last						
inspection.12/4/2013 Slopes were cleared of vegetation and are in						
good condition.7/09/2013 Same as last inspection.4/24/2012						
Limited inspection on WS and LS slopes due to dense vegetation. Need						
photos of WS and LS slopes during next inspeciton with cleared						
slopes.

View of crossing from LS. Dense vegetation along LS slope limited visual inspection. (LS Photo 1 of 2)

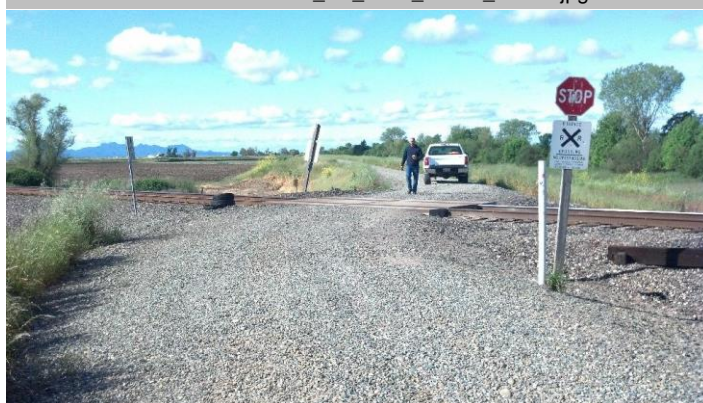
Photo 1 of 3 : UCIP_FA_2018_52148_67292.jpg

FS_ID:52148
DS_ID:18912
EP_NO: N/A
Repair Type: Non-Urgent
Crossing Status: Indicator Found
UCIP Comments: 6/5/2017 Crossing appears to be in good condition.
(DWR Sutter Yard- A Freitag)11/18/2016 Crossing appears to be in good condition. Another marker was found/photographed near the LS toe. Crossing also appears to cross through the Unit1 levee around CLM8.860. (DWR Sutter Yard- A Freitag)4/27/2016 Crossing appears to be in good condition.6/30/2015 Crossing is in good condition.5/28/2014 Same as last inspection.12/4/2013 Same as last inspection.7/09/2013 Same as last inspection.4/24/2012 Unable to determine if crossing is an authorized or unauthorized encroachment. Unable to find permit number for this encroachment. Will need to coordinate with LMA Superintendent and DWR-Inspector, photo includes utility contact information.
FIELD_STRUCT_DESC: Buried communication line of unknown material through the levee at an unknown depth below the crown. Owner of line is Qwest Communications 1-800 At Fiber Sign ID Number 16601 as indicated by marker. (Qwest Communication) No permit has been identified since crossing was field discovered in 2012.

Overview of levee crown at crossing.

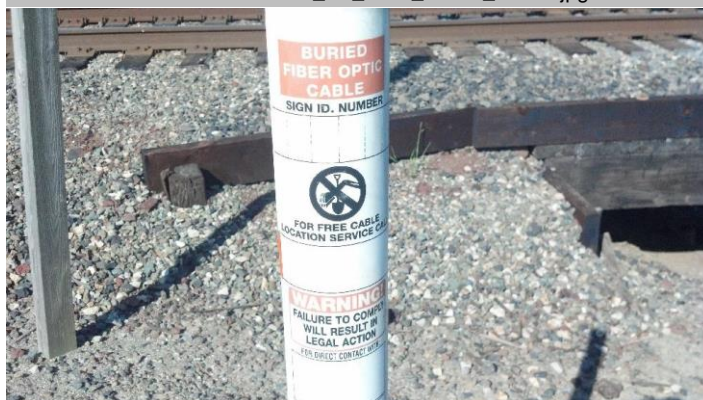
Photo 2 of 3 : UCIP_FA_2018_52148_67291.jpg

Marker for buried fiber optic cable on WS.

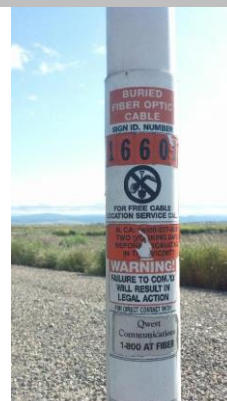
Photo 3 of 3 : UCIP_FA_2018_52148_67290.jpg

Marker for buried fiber optic cable on LS with contact information.

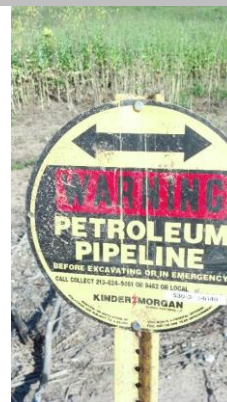
Photo 2 of 3 : UCIP_FA_2018_52149_67294.jpg

FS_ID:52149
DS_ID:18913
EP_NO: N/A
Repair Type: Non-Urgent
Crossing Status: Indicator Found
UCIP Comments: 6/5/2017 Crossing appears to be in good condition.
(DWR Sutter Yard- A Freitag)11/18/2016 Crossing appears to be in good condition. (DWR Sutter Yard- A Freitag)4/27/2016 Crossing appears to be in good condition.6/30/2015 Crossing appears to be in good condition. But still unknown if this crossing was authorized or unauthorized.5/28/2014 Same as last inspection.12/4/2013 Same as last inspection.7/9/2013 Same as last inspection.4/24/2012 Authorized/unauthorized encroachment? Contact Chico Local Area Manager, Frank Villalovos 530.342.6140 (o) or 530.624.4048 (c) or email villalovosf@kindermorgan.com for additional info. Inquiries pertaining to inspection submit to pipelineinquiries@kindermorgan.com and reference as Engr Station 3173+48 plus include coordinates.
FIELD_STRUCT_DESC: 8-inch high pressure line bored through the levee at depth unknown. Kinder Morgan is the owner of line--contact information is 213.624-9461 or Chico Local Area Manager, Frank Villalovos 530.342.6140 (o) or 530.624.4048 (c) or email villalovosf@kindermorgan.com. Additional contact is Ken Yeo, Sacramento Local Area Manager, at 916.416.7938 or by email yeok@kindermorgan.com. Frank Villalovos is the primary contact for this crossing. No permit has been identified since crossing was field discovered in 2012.

WS marker with utility contact information.

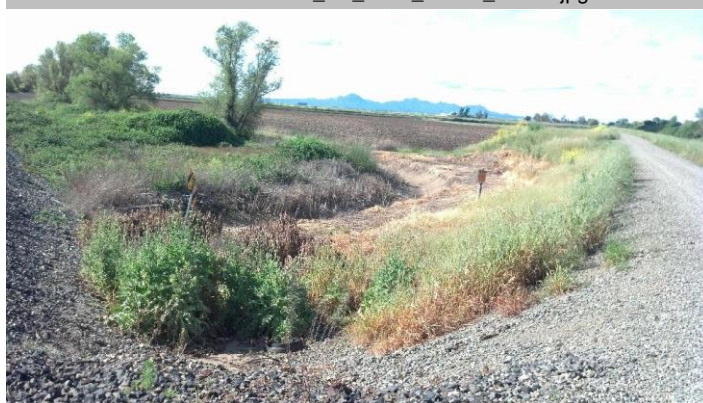
Photo 3 of 3 : UCIP_FA_2018_52149_67293.jpg

View of LS slope and marker.

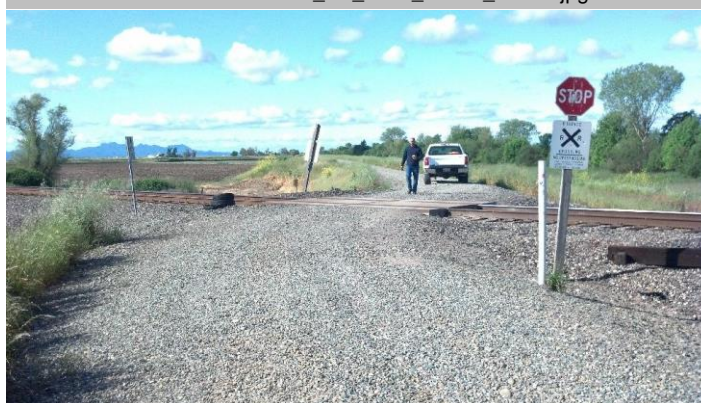
Photo 1 of 3 : UCIP_FA_2018_52150_67299.jpg

FS_ID:52150
DS_ID:18914
EP_NO: N/A
Repair Type: Non-Urgent
Crossing Status: Indicator Found
UCIP Comments: 6/5/2017 Crossing appears to be in good condition.
(DWR Sutter Yard- A Freitag)11/18/2016 Crossing appears to be in good condition. (DWR Sutter Yard- A Freitag)4/27/2016 Crossing appears to be in good condition.6/30/2015 Crossing appears to be in good condition. It is still unknown whether this crossing was authorized or unauthorized.5/28/2014 Same as last inspection.12/4/2013 Same as last inspection.7/09/2013 Same as last inspection.4/24/2012 Unable to determine if crossing is an authorized or unauthorized encroachment. Unable to find permit number for this crossing. Will need to coordinate with Pacific Telephone to determine if permit exist for this crossing.
FIELD_STRUCT_DESC: Underground communication cable through the levee, depth unknown below the crown. Owner of encroachment is Pacific Telephone. No permit has been identified since crossing was field discovered in 2012.

Overview of levee crown at crossing.

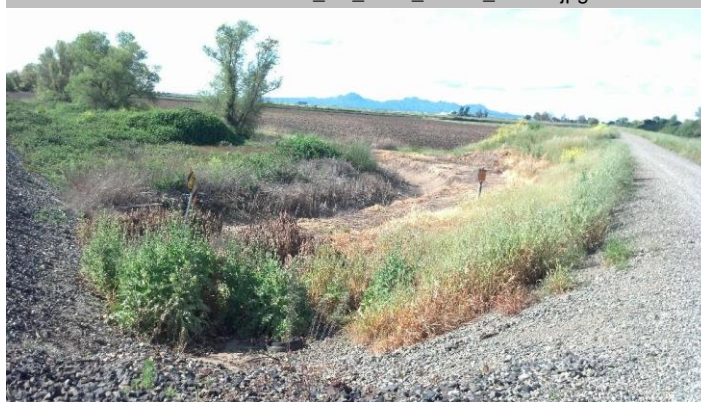
Photo 2 of 3 : UCIP_FA_2018_52150_67300.jpg

Marker located on LS.

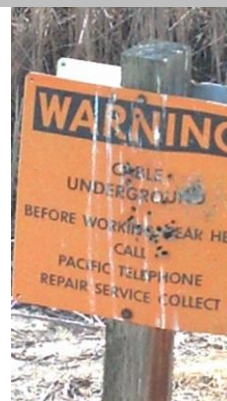
Photo 3 of 3 : UCIP_FA_2018_52150_67298.jpg

Underground cable marker with contact information.

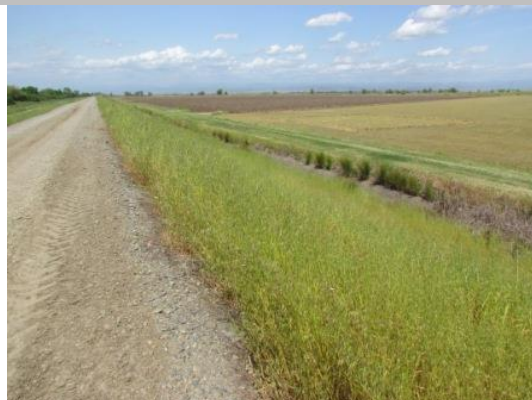
Photo 1 of 1 : FA_2018_MA0013_301_13_20180905_00005.jpg

LM Start	10.03	Rating **	M	Issue No.	13
LM End	10.52	Issue Type +	En	Location *	LS
Category	Earthen Levee			GPS Latitude/Longitude	
				Start	End
Item	Encroachments			39.471517 °	39.465113 °
				-121.739433 °	-121.743592 °
DWR ID	DWR_MA0013_02_s_2012_13				
Comment Code					
DT : Ditch					
Inspector Comment

View of the agricultural ditch along the toe.

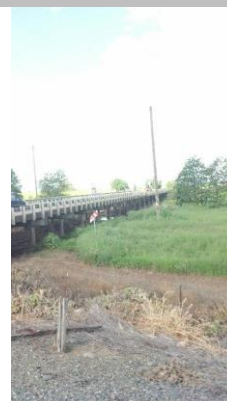
Photo 1 of 1 : UCIP_FA_2018_52153_67334.jpg

Comment Code					
Inspector Comment					
FS_ID:52153 DS_ID:16472 EP_NO: 10939 Repair Type: Non-Urgent Crossing Status: Indicator Found UCIP Comments: 6/5/2017 Pole still present. (DWR Sutter Yard-AFreitag)11/17/2016 Pole still present within channel. (DWR Sutter Yard- AFreitag)4/26/2016 Pole within the channel not removed per permit description.6/30/2015 same as last inspection.5/28/2014 Same as last inspection.12/4/2013 Same as last inspection.7/08/2013 Same as last inspection.4/24/2012 According to permit the existing pole and buried cable in the overflow area were to be removed. Pole is present in the channel. FIELD_STRUCT_DESC: Reroute a buried wire across the left bank levee of Cherokee Canal at State Highway 162 Bridge abutment from that point to the downstream side of the bridge. From there the wire extends to the gaging station at the center of the bridge. The facility maintains service to the Department of Water Resources' Metering Station midspan of the bridge. (Permit No. 10939, 1976 - Pacific Telephone and Telegraph Company [PT&T]) FS Date: 6/8/2017 8:52:41 AM

Pole within the channel was not removed.

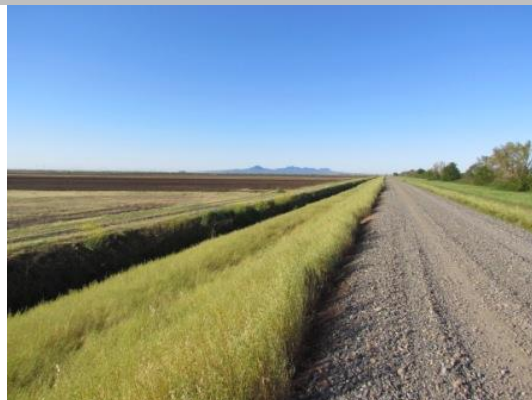
Photo 1 of 1 : FA_2018_MA0013_301_18_20180905_00006.jpg

LM Start	10.59	Rating **	M	Issue No.	18
LM End	11.66	Issue Type +	En	Location *	LS
Category	Earthen Levee			GPS Latitude/Longitude	
				Start	End
Item	Encroachments			39.464305 °	39.450333 °
				-121.744172 °	-121.753157 °
DWR ID	DWR_MA0013_02_s_2012_18				
Comment Code					
DT : Ditch					
Inspector Comment

View of the agricultural ditch along the toe.

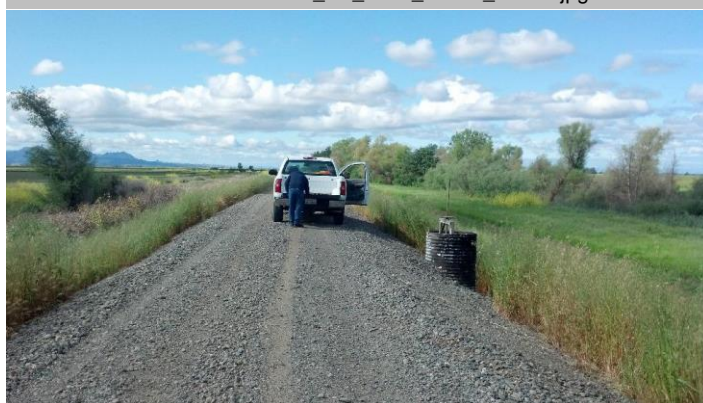
Photo 1 of 3 : UCIP_FA_2018_52154_67336.jpg

FS_ID:52154
DS_ID:16385
EP_NO: N/A
Repair Type: Non-Urgent
Crossing Status: Found
UCIP Comments: 5/30/2017 WS end cannot be located due to heavy vegetation. LS screwgate was mostly submerged during site visit. Pipe has been selected to be internally cleaned and inspected as part of the DMP project. (DWR Sutter Yard- A Freitag)11/17/2016 WS still heavily vegetated and cannot access the WS pipe end for inspection. Vegetation needs to be cleared back. (DWR Sutter Yard- A Freitag)4/26/2016 LS headwall was visible but gate was underwater. WS still heavily vegetated and unable to be inspected. Vegetation needs to be cleared back.6/30/2015 WS heavily vegetated passed the toe-road and could not make it to the WS pipe end for inspection. Vegetation needs to be cleared back. LS pipe end was fully submerged under water.5/28/2014 Same as last inspection.12/4/2013 Same as last inspection.7/08/2013 LS slope has been cleared of vegetation and is in good condition. LS headwall is now visible but mostly underwater so unable to do full inspection. WS is still vegetated.4/24/2012 LS pipe & slide gate sedimented in. Limited inspection WS and LS slopes due to dense vegetation. Need photos of cleared WS and LS slopes during next inspection. This crossing was listed in the USACE Periodic Inspection report as Corp's inspect ID# USACE_CESPK_M13F_2011_p_0147 for limited visibility of LS and WS.

Overview of crossing looking downstream at the left bank of Cherokee Canal.

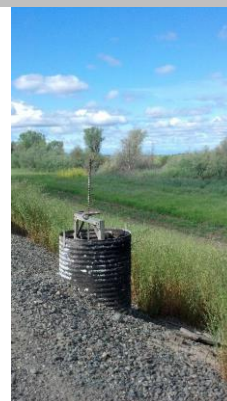
Photo 2 of 3 : UCIP_FA_2018_52154_67337.jpg

Stand pipe with screw gate WS

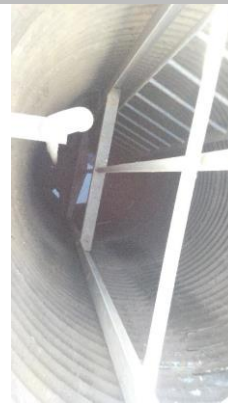
Photo 3 of 3 : UCIP_FA_2018_52154_67335.jpg

View of the inside of the WS stand pipe. No obstructions blocking slide gate.

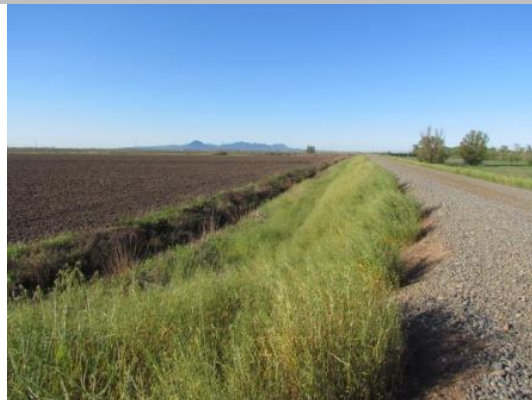
Photo 1 of 1 : FA_2018_MA0013_301_19_20180905_00007.jpg

LM Start	13.40	Rating **	M	Issue No.	19
LM End	16.00	Issue Type +	En	Location *	LS
Category	Earthen Levee			GPS Latitude/Longitude	
				Start	End
Item	Encroachments			39.428192°	39.414202°
				-121.768443°	-121.781863°
DWR ID	DWR_MA0013_02_s_2012_19				
Comment Code					
DT : Ditch					
Inspector Comment

View of the agricultural ditch along the toe.

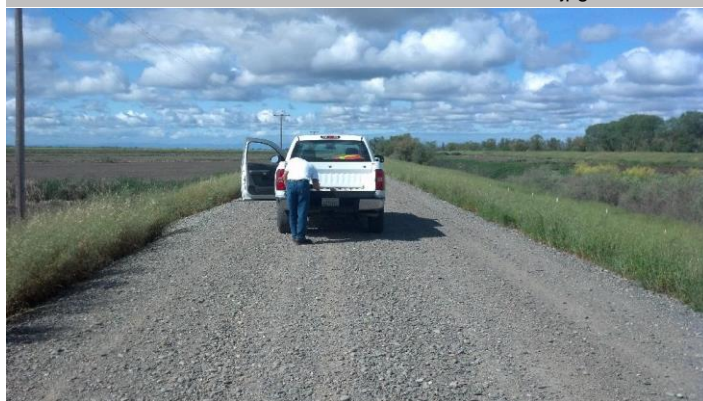
Photo 1 of 3 : UCIP_FA_2018_52156_67341.jpg

FS_ID:52156
DS_ID:16376
EP_NO: N/A
Repair Type: Non-Urgent
Crossing Status: Found
UCIP Comments: 5/30/2017 LS pipe end is buried and location unknown. WS flap gate is bolted shut. Pipe has been selected to be internally cleaned and inspected as part of the DMP project. (DWR Sutter Yard- A Freitag)11/17/2016 Unable to locate LS pipe end. WS flap gate bolted shut. (DWR Sutter Yard- A Freitag)4/26/2016 LS inlet appears to be buried as could not locate it. WS flap gate was bolted shut. This appears to be an abandoned crossing.6/30/2015 Still unable to locate the LS pipe end. 5/28/2014 Same as last inspection.12/4/2013 Same as last inspection. WS flapgate was bolted shut to keep LS ricefield flooded.7/08/2013 WS slope has been cleared of vegetation and is in good condition. LS slope also cleared of vegetation but still very dense on LS toe and unable to locate LS headwall.4/24/2012 Could not find LS end of pipe. Limited inspection on WS and LS slopes and toe due to dense vegetation. Need photos of cleared WS and LS slopes, and LS headwall during next inspection. This crossing was listed in the USACE Periodic Inspection report as Corp's inspect ID# USACE_CESPK_M13E_2011_p_0011 for WS gate blocked by vegetation.

Overview of crossing looking downstream at the left bank of Cherokee Canal.

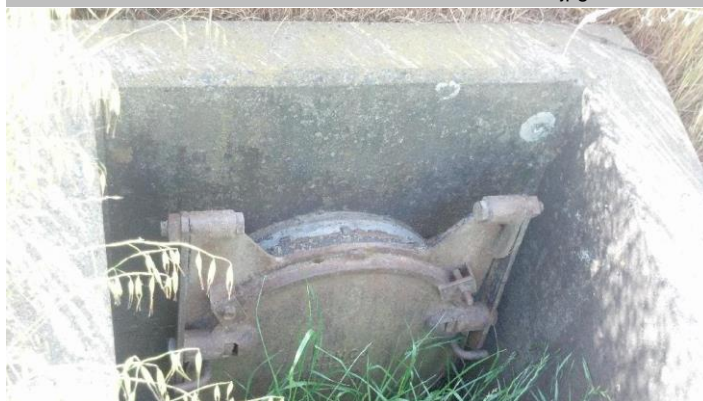
Photo 3 of 3 : UCIP_FA_2018_52156_67342.jpg

FS_ID:52156
DS_ID:16376
EP_NO: N/A
Repair Type: Non-Urgent
Crossing Status: Found
UCIP Comments: 5/30/2017 LS pipe end is buried and location unknown. WS flap gate is bolted shut. Pipe has been selected to be internally cleaned and inspected as part of the DMP project. (DWR Sutter Yard- AFreitag)11/17/2016 Unable to locate LS pipe end. WS flap gate bolted shut. (DWR Sutter Yard- AFreitag)4/26/2016 LS inlet appears to be buried as could not locate it. WS flap gate was bolted shut. This appears to be an abandoned crossing.6/30/2015 Still unable to locate the LS pipe end. 5/28/2014 Same as last inspection.12/4/2013 Same as last inspection. WS flapgate was bolted shut to keep LS ricefield flooded.7/08/2013 WS slope has been cleared of vegetation and is in good condition. LS slope also cleared of vegetation but still very dense on LS toe and unable to locate LS headwall.4/24/2012 Could not find LS end of pipe. Limited inspection on WS and LS slopes and toe due to dense vegetation. Need photos of cleared WS and LS slopes, and LS headwall during next inspection. This crossing was listed in the USACE Periodic Inspection report as Corp's inspect ID# USACE_CESPK_M13E_2011_p_0011 for WS gate blocked by vegetation.

View of WS headwall and flap gate.

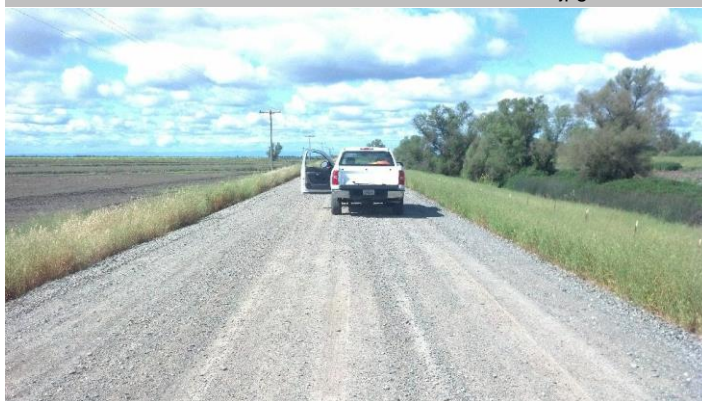
Photo 1 of 3 : UCIP_FA_2018_52157_67352.jpg

FS_ID:52157
DS_ID:16382
EP_NO: N/A
Repair Type: Non-Urgent
Crossing Status: Found
UCIP Comments: 5/30/2017 LS pipe end is buried and location unknown. WS flap gate bolted shut. Pipe has been selected to be internally cleaned and inspected as part of the DMP project. (DWR Sutter Yard- A Freitag)11/17/2016 Unable to locate LS pipe end. WS flap gate bolted shut. (DWR Sutter Yard- A Freitag)4/26/2016 Appears to be an abandoned crossing. LS pipe end was still buried and WS flap gate was bolted shut.6/30/2015 LS headwall stil buried somewhere. WS looked to be in good condition.5/28/2014 Same as last inspection.12/4/2013 Same as last inspection.7/08/2013 Same as last inspection.4/24/2012 LS headwall buried. Limited inspection on WS and LS slopes due to dense vegetation. Need photos of cleared WS and LS slopes during next inspection. Need to determine the fate of LS headwall. This crossing was listed in the USACE Periodic Inspection report as Corp's inspect ID# USACE_CESPK_M13E_2011_p_0022 -- unknown issue.

Overview of crossing looking downstream of the left bank of Cherokee

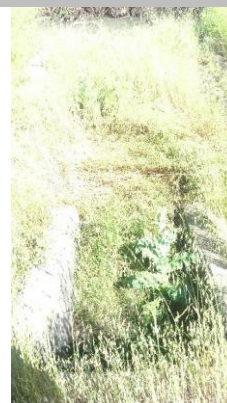
Photo 3 of 3 : UCIP_FA_2018_52157_67350.jpg

View of WS headwall.

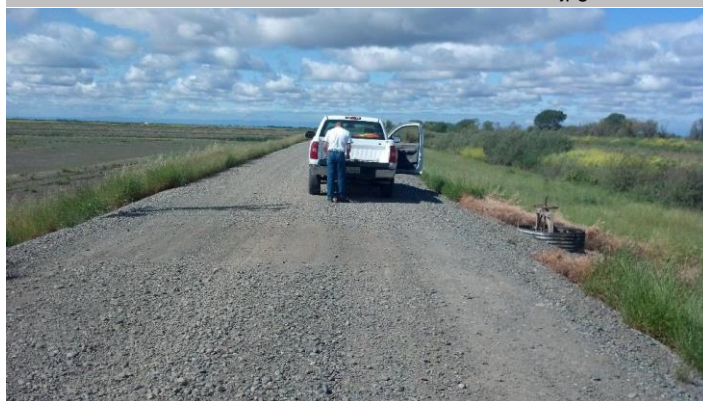
Photo 1 of 3 : UCIP_FA_2018_52158_67353.jpg

UCIP Comments: 5/30/2017 LS headwall was mostly buried and pipe end over 50% full of sediment. WS distribution box appears to have not been repaired yet but it does not seem to affect the integrity of the levee. (DWR Sutter Yard- A Freitag)11/17/2016 LS pipe end was about 50% plugged with soil. WS riser box is still cracked and appears to still be leaking. (DWR Sutter Yard- A Freitag)4/26/2016 LS headwall was dry and photographed. LS pipe end was about 50% plugged with soil. WS riser box is still cracked and appears to still be leaking. 6/30/2015 Bee boxes stacked near the riser box on WS so could not get close enough to see if the leak issue had been fixed.

5/28/2014 Water appears to be leaking out of the WS concrete riser box. Causing minor erosion under pipe near pump structure. 12/4/2013 Same as last inspection. 7/08/2013 LS slope has been cleared of vegetation and is in good condition. LS headwall was underwater and unable to be inspected. All WS appurtenances in good condition. 4/24/2012 Limited inspection on LS slope due to dense vegetation. Need photos of cleared LS slope and LS headwall. Cracks in riser box. New pump installed recently this work might be covered under separate permit.

Overview of levee crown.

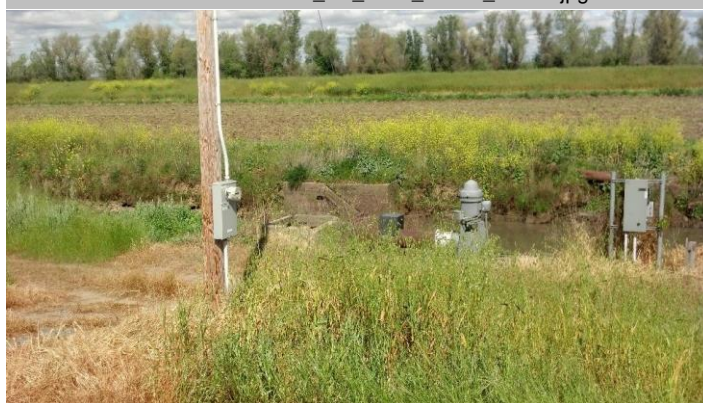
Photo 2 of 3 : UCIP_FA_2018_52158_67359.jpg

Appurtenances on WS.

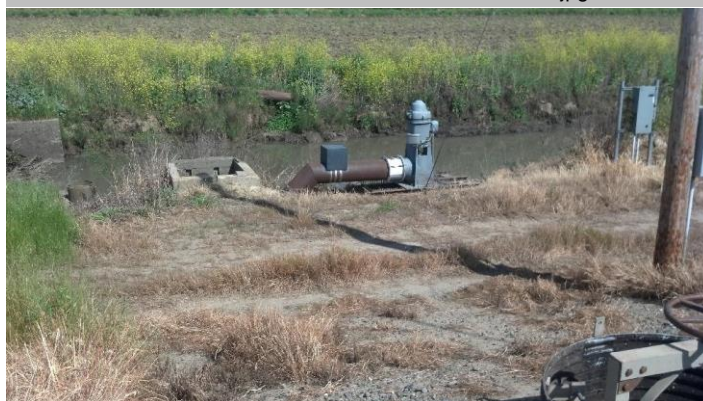
Photo 3 of 3 : UCIP_FA_2018_52158_67355.jpg

WS view of crossing.

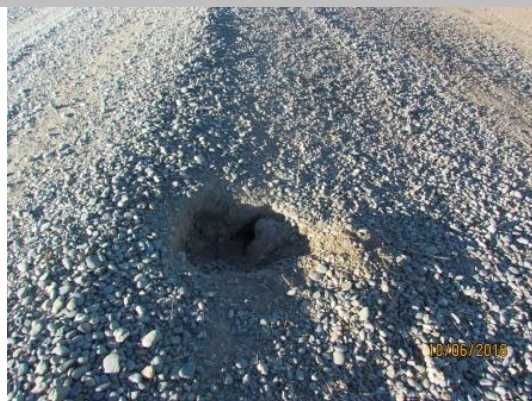
Photo 1 of 1 : FA_2018_MA0013_301_54_20180905_00012.jpg

LM Start	16.52	Rating **	M	Issue No.	54
LM End	16.52	Issue Type +	Ma	Location *	WS
Category	Earthen Levee			GPS Latitude/Longitude	
				Start	End
Item	Animal Control			39.409548 °	39.409548 °
				-121.789668 °	-121.789668 °
DWR ID	DWR_MA0013_02_f_2014_54				
Comment Code					
A3 : No rodents visible, but rodent burrows visible; need to backfill and compact or grout burrows.					
Inspector Comment

View of the rodent holes along the waterside slope.

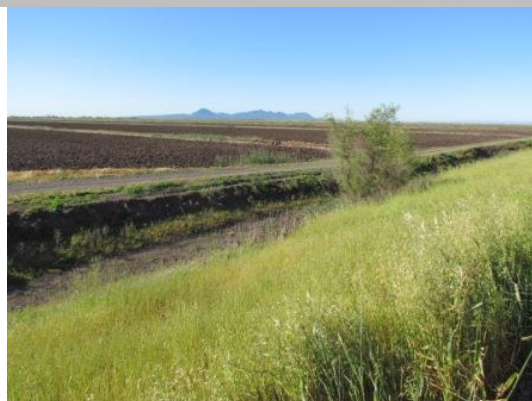
Photo 1 of 1 : FA_2018_MA0013_301_20_20180905_00008.jpg

LM Start	16.89	Rating **	M	Issue No.	20
LM End	18.72	Issue Type +	En	Location *	LS
Category	Earthen Levee			GPS Latitude/Longitude	
				Start	End
Item	Encroachments			39.406217 °	39.389187 °
				-121.794945 °	-121.821233 °
DWR ID	DWR_MA0013_02_s_2012_20				
Comment Code					
DT : Ditch					
Inspector Comment

View of the agricultural ditch along the toe.

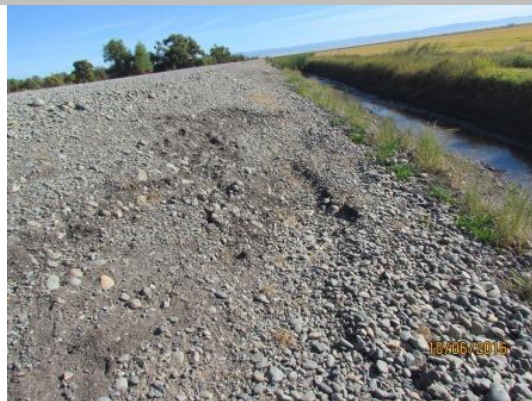
Photo 1 of 1 : FA_2018_MA0013_301_69_20180905_00018.jpg

LM Start	17.64	Rating **	M	Issue No.	69
LM End	17.64	Issue Type +	Ma	Location *	LS
Category	Earthen Levee			GPS Latitude/Longitude	
				Start	End
Item	Slope Stability			39.399164 °	39.399164 °
				-121.805787 °	-121.805787 °
DWR ID	DWR_MA0013_02_f_2016_69				
Comment Code					
S1 : Repair slope instability.					
Inspector Comment

View of slope instability issue along the landside slope.

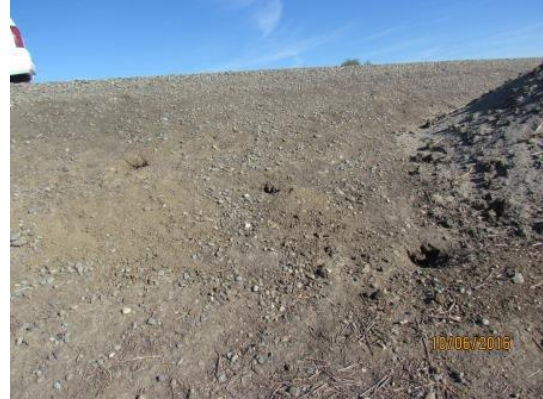
Photo 1 of 1 : FA_2018_MA0013_301_70_20180905_00019.jpg

LM Start	17.90	Rating **	M	Issue No.	70
LM End	17.90	Issue Type +	Ma	Location *	LS
Category	Earthen Levee			GPS Latitude/Longitude	
				Start	End
Item	Animal Control			39.396809 °	39.396809 °
				-121.809422 °	-121.809422 °
DWR ID	DWR_MA0013_02_f _ 2016_70				
Comment Code					
A3 : No rodents visible, but rodent burrows visible; need to backfill and compact or grout burrows.					
Inspector Comment

View of the rodent holes along the landside slope.

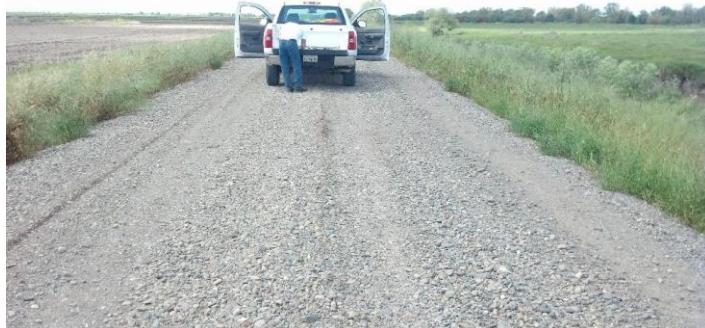
Photo 1 of 3 : UCIP_FA_2018_52161_67387.jpg

FS_ID:52161
DS_ID:16379
EP_NO: N/A
Repair Type: No Action Needed
Crossing Status: Found
UCIP Comments: 5/30/2017 Crossing appears to be in good condition. Pipe has been selected to be internally cleaned and inspected as part of the DMP project. (DWR Sutter Yard- A Freitag) 11/17/2016 Crossing appears to be in good condition. (DWR Sutter Yard- A Freitag) 4/26/2016 Crossing appears to be in good condition. 6/30/2015 Vegetation still present on WS. LS side was underwater during inspection. 5/28/2014 Same as last inspection. 12/4/2013 Same as last inspection. 7/08/2013 LS slope cleared of vegetation and is in good condition. WS is still vegetated. LS pipe end under water and blocked off by plywood so unable to measure culvert size. 4/24/2012 Limited inspection on WS and LS slopes due to dense vegetation. Need photos of cleared WS and LS slopes. This crossing was listed in the USACE Periodic Inspection report as Corp's inspect ID# USACE_CESPK_M13E_2011_p_0134 for unknown culvert size on LS and no outlet visible on WS.

Overview of crossing looking D/S at left bank of Cherokee Canal.

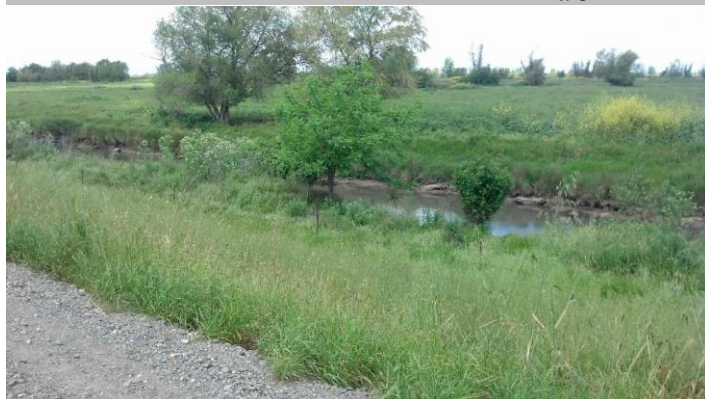
Photo 2 of 3 : UCIP_FA_2018_52161_67386.jpg

View of WS slope and berm.

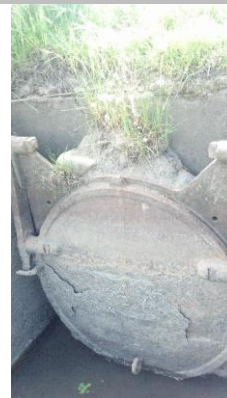
Photo 3 of 3 : UCIP_FA_2018_52161_67390.jpg

View of flap gate located on WS.
